# **Navajo Abandoned Uranium Mine**

## **Site Screen Report**

### **Enos Johnson AUM Site**

#### **Navajo AUM Northern Region**

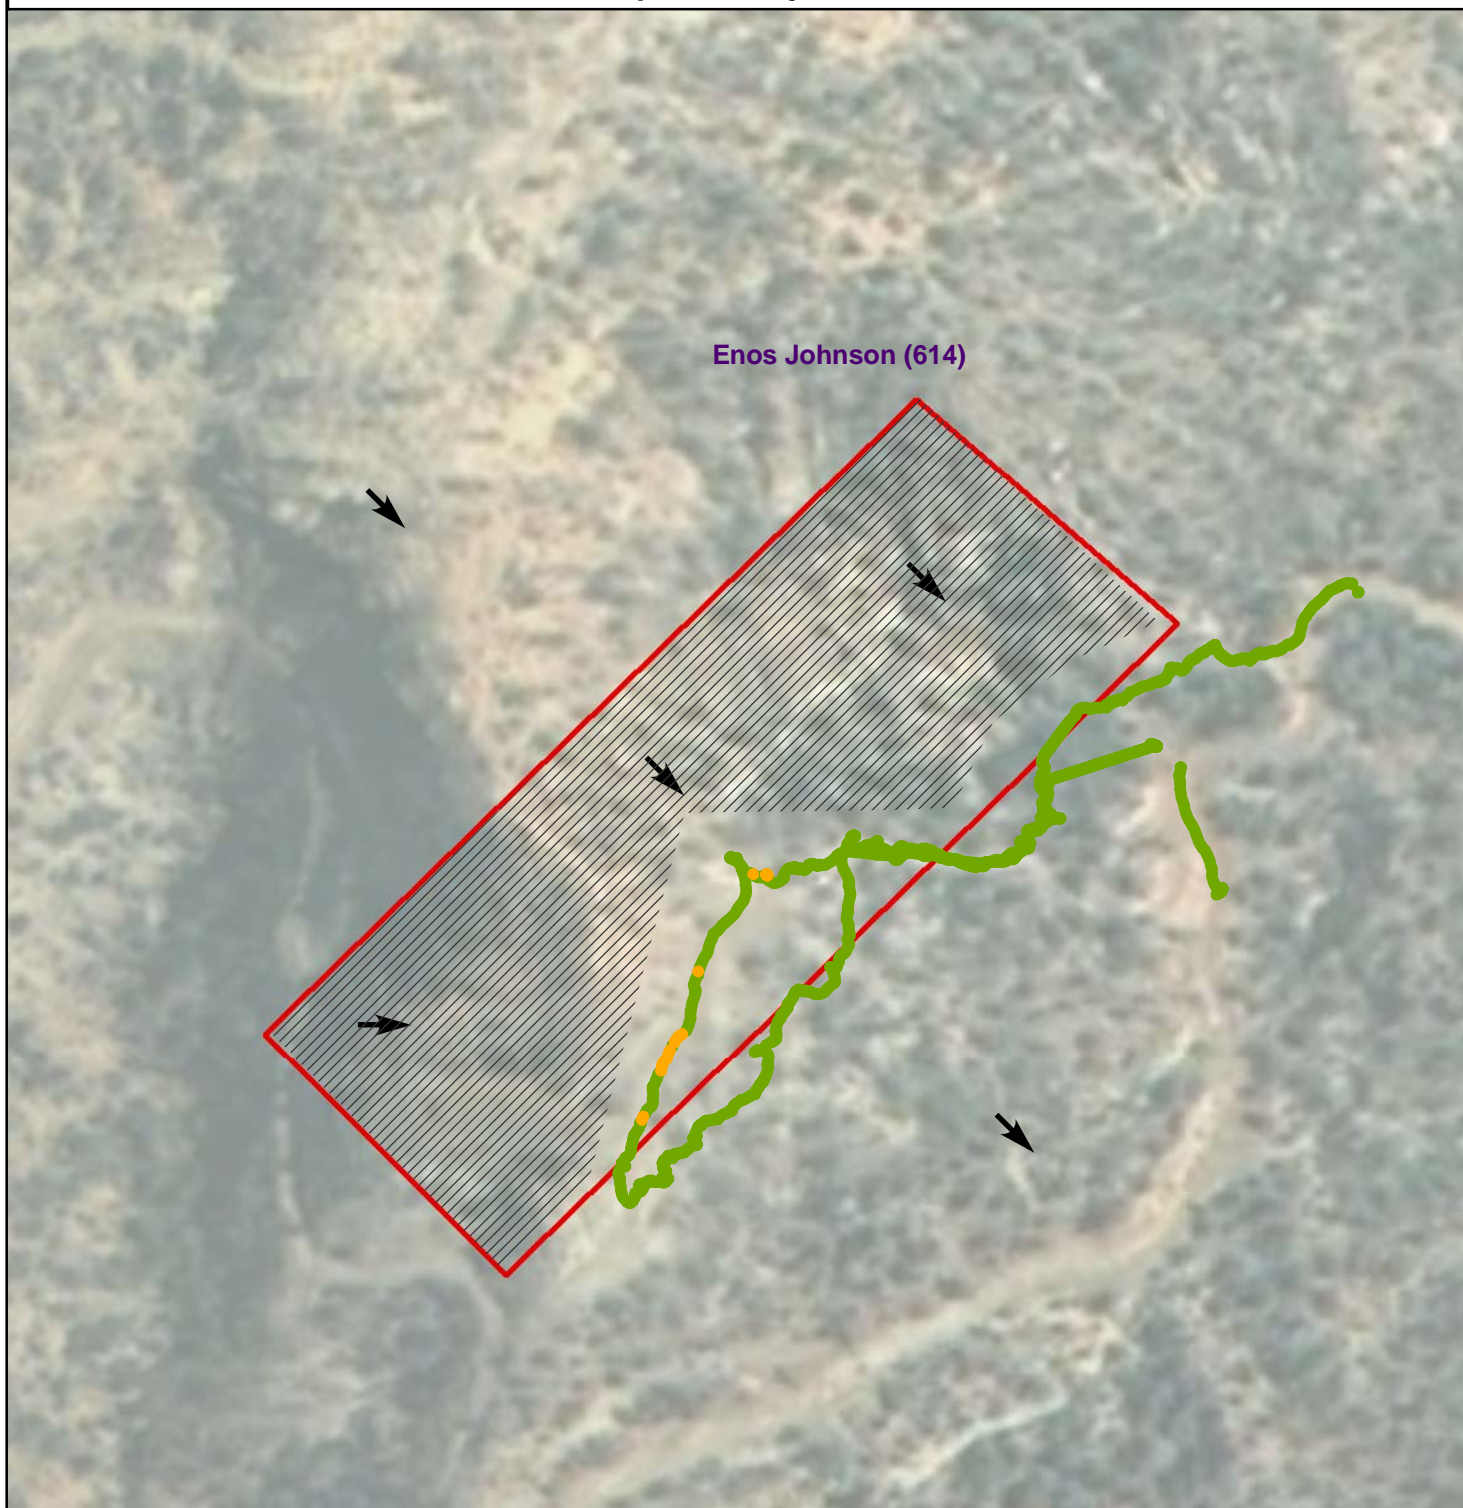
A total of 2,267 gamma radiation measurements were collected from the mine site, ranging from 10,920 cpm to 33,538 cpm. The measurements are represented in Figures 8 and 9.

**Figure 8 - Gamma Radiation Measurements, Above Two Times Background**  
**Enos Johnson (614)**  
**Sanostee Chapter, Navajo Nation, Arizona**

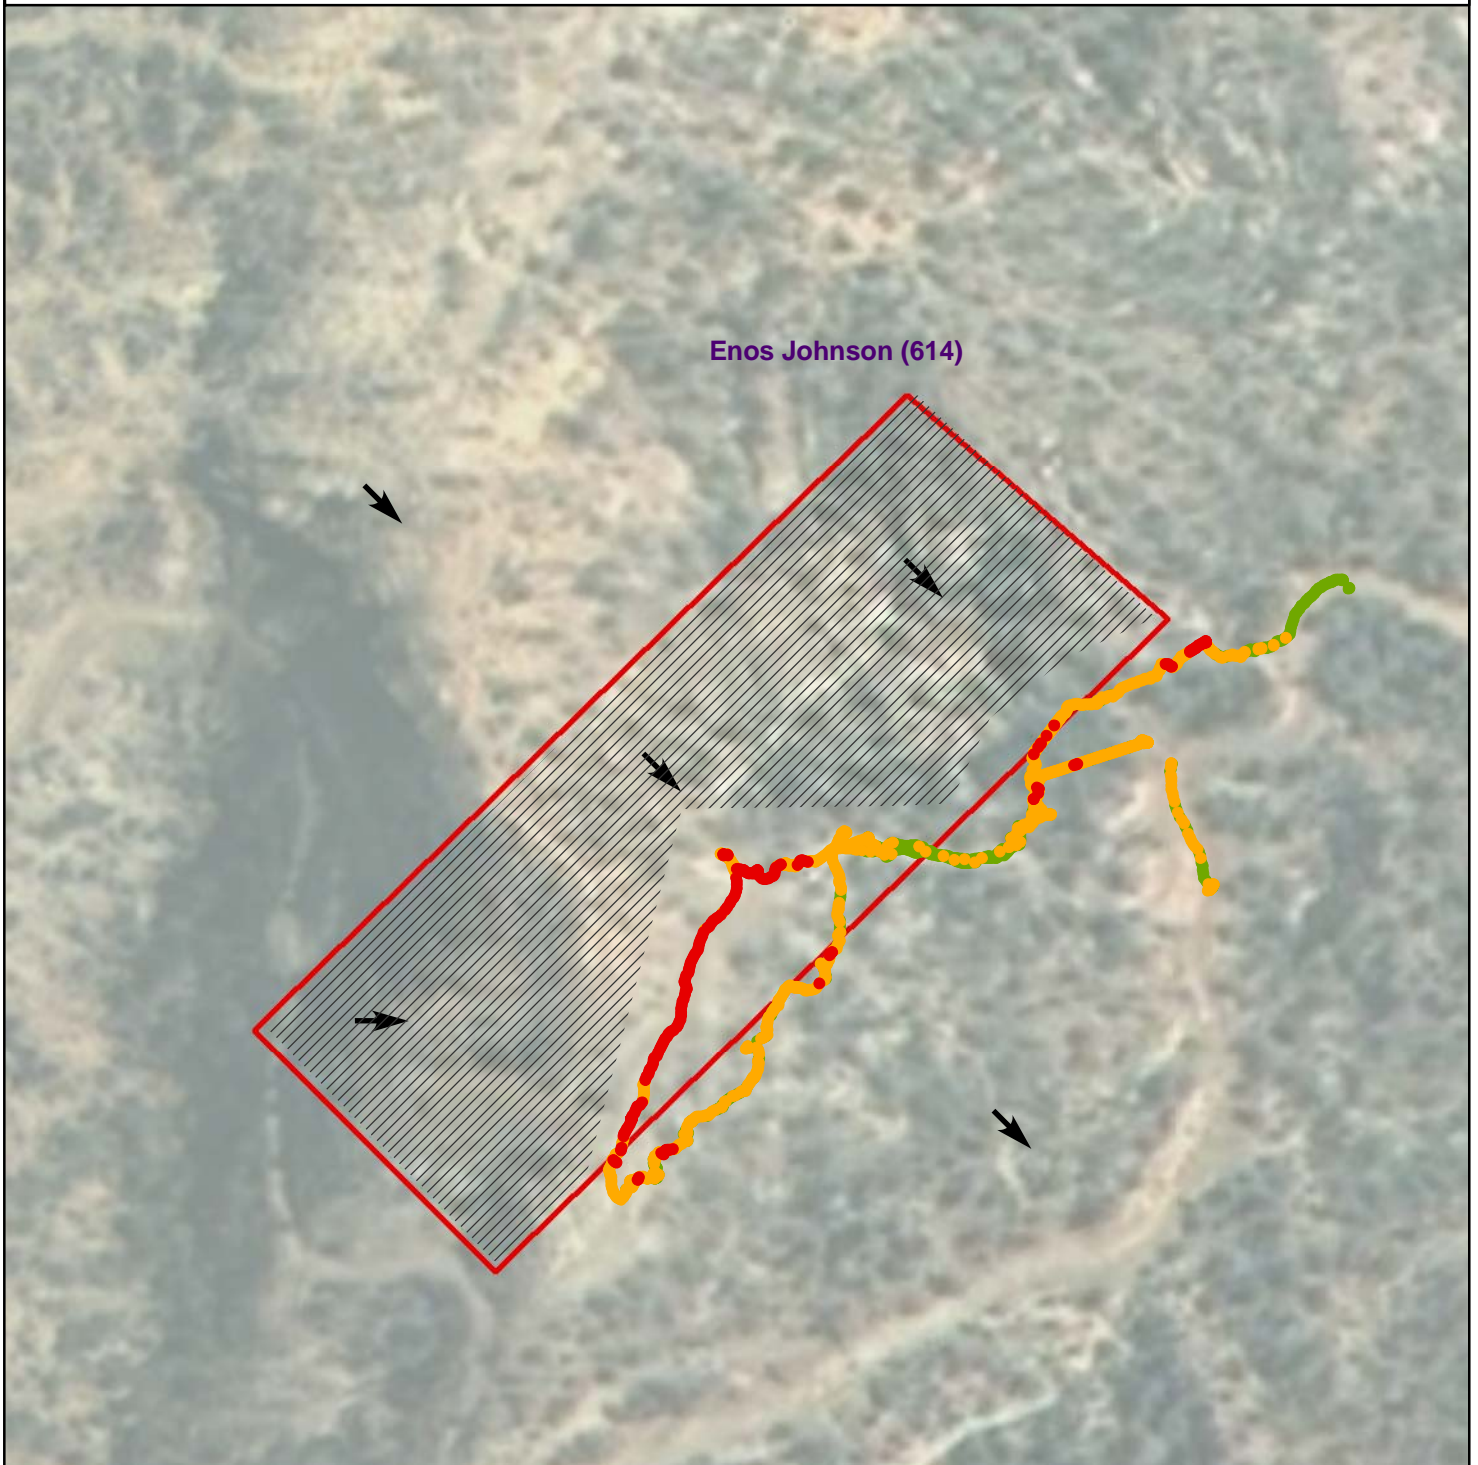
**Figure 9 - Gamma Radiation Measurements**  
**Enos Johnson (614)**  
**Sanostee Chapter, Navajo Nation, Arizona**
